Rock Art Management and Landscape Change: Mixed Field Assessment Techniques for Cultural Stone Decay

Rock Art Management and Landscape Change:
Mixed Field Assessment Techniques for Cultural Stone Decay

A dissertation submitted in partial fulfillment
of the requirements for the degree of
Doctorate of Philosophy in Environmental Dynamics

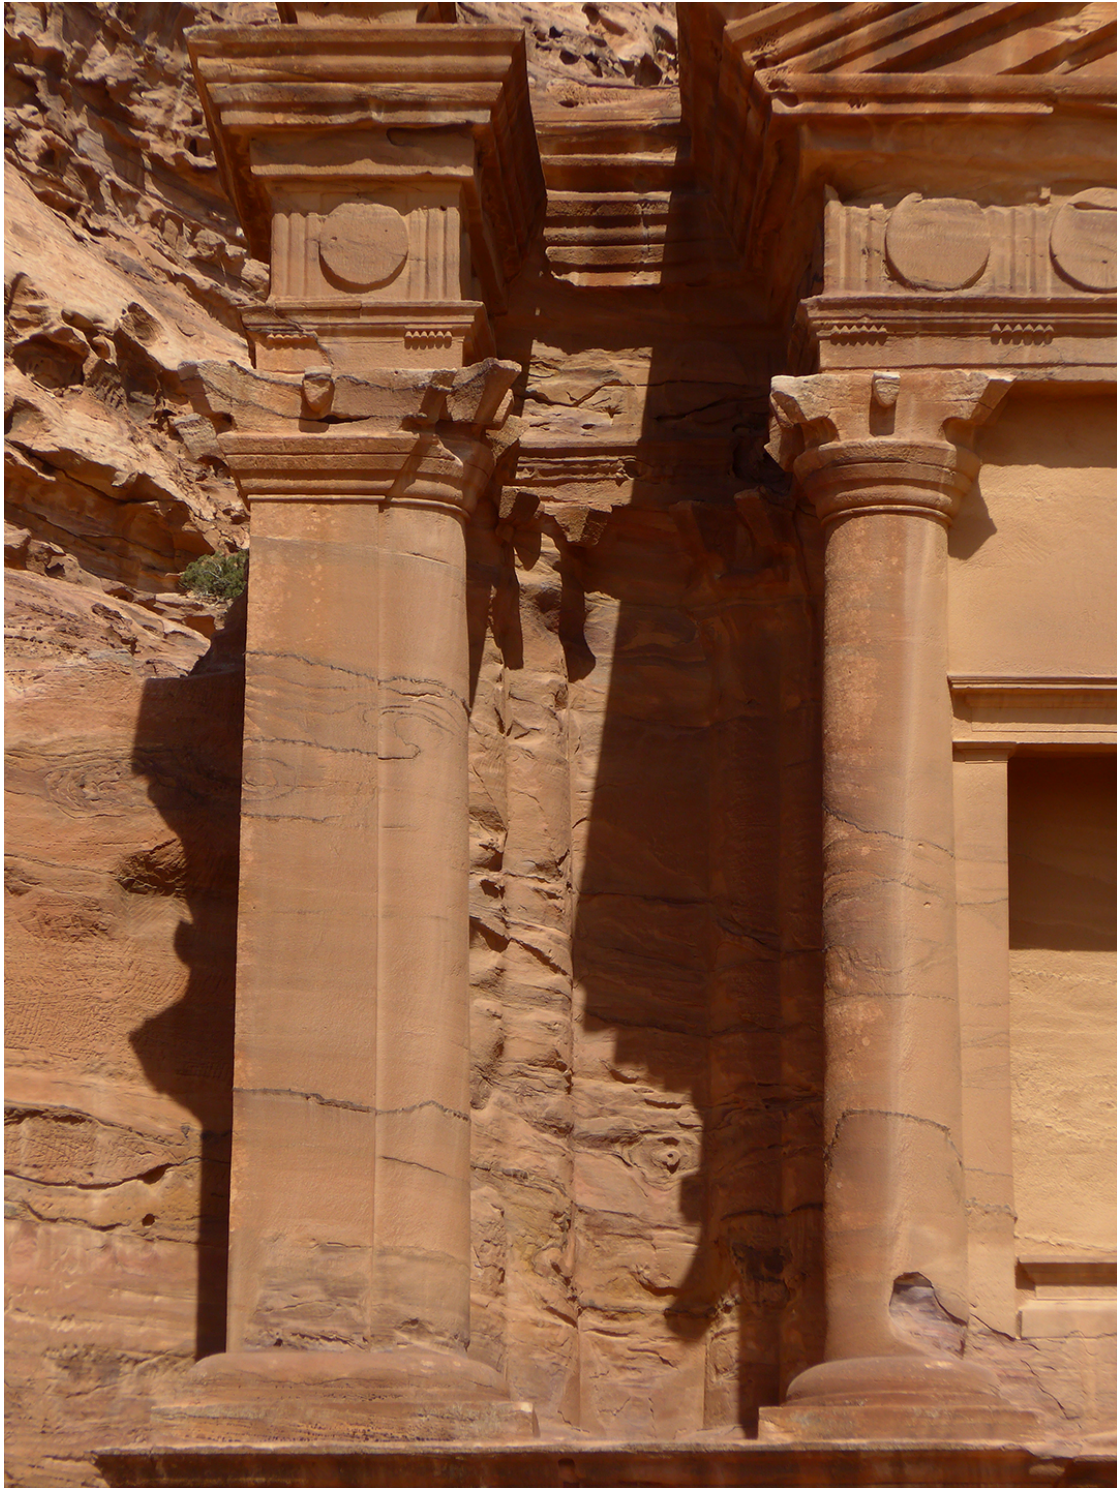
I.2 – Front and back of completed CSSI score sheet for ad-Deir Panel 4.

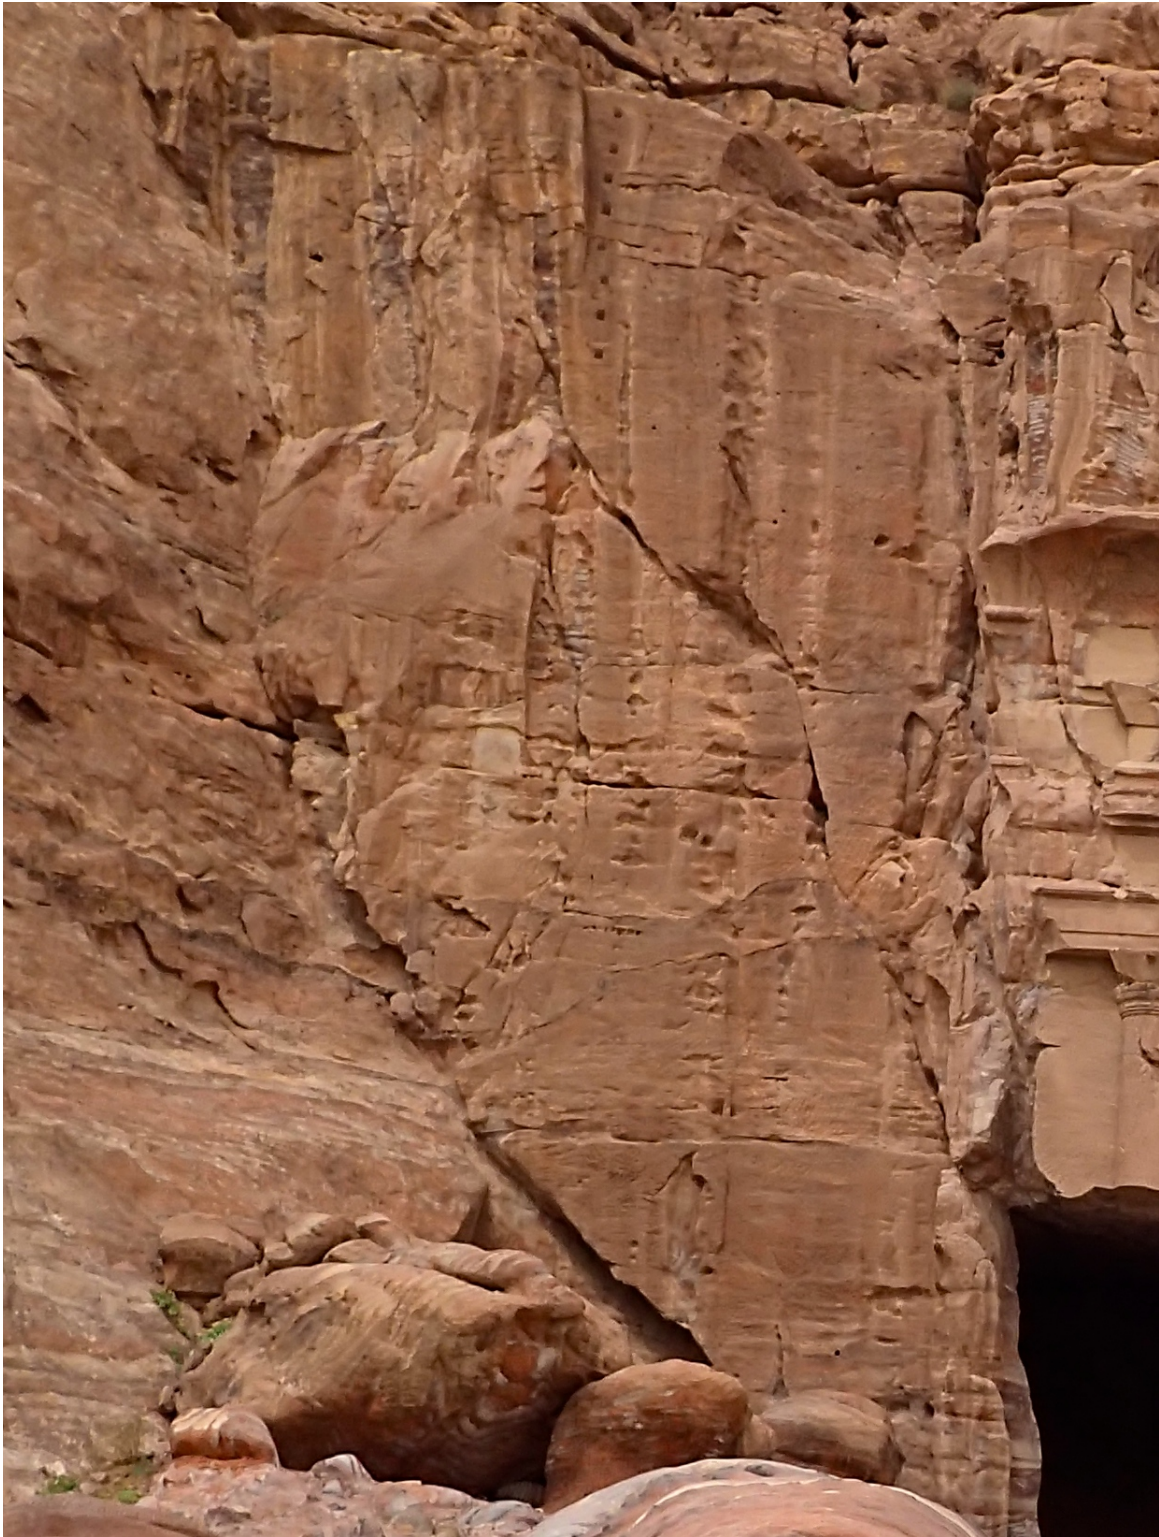
I.7 – Turkmanyia Panel 1—the left contextual panel for the monument. Not wanting to exclude surrounding decay, CSSI assessments were also conducted on immediately surrounding rock faces, most of which were artificially flattened and/or dressed in typical Nabataean style. Photograph by author, 2016.

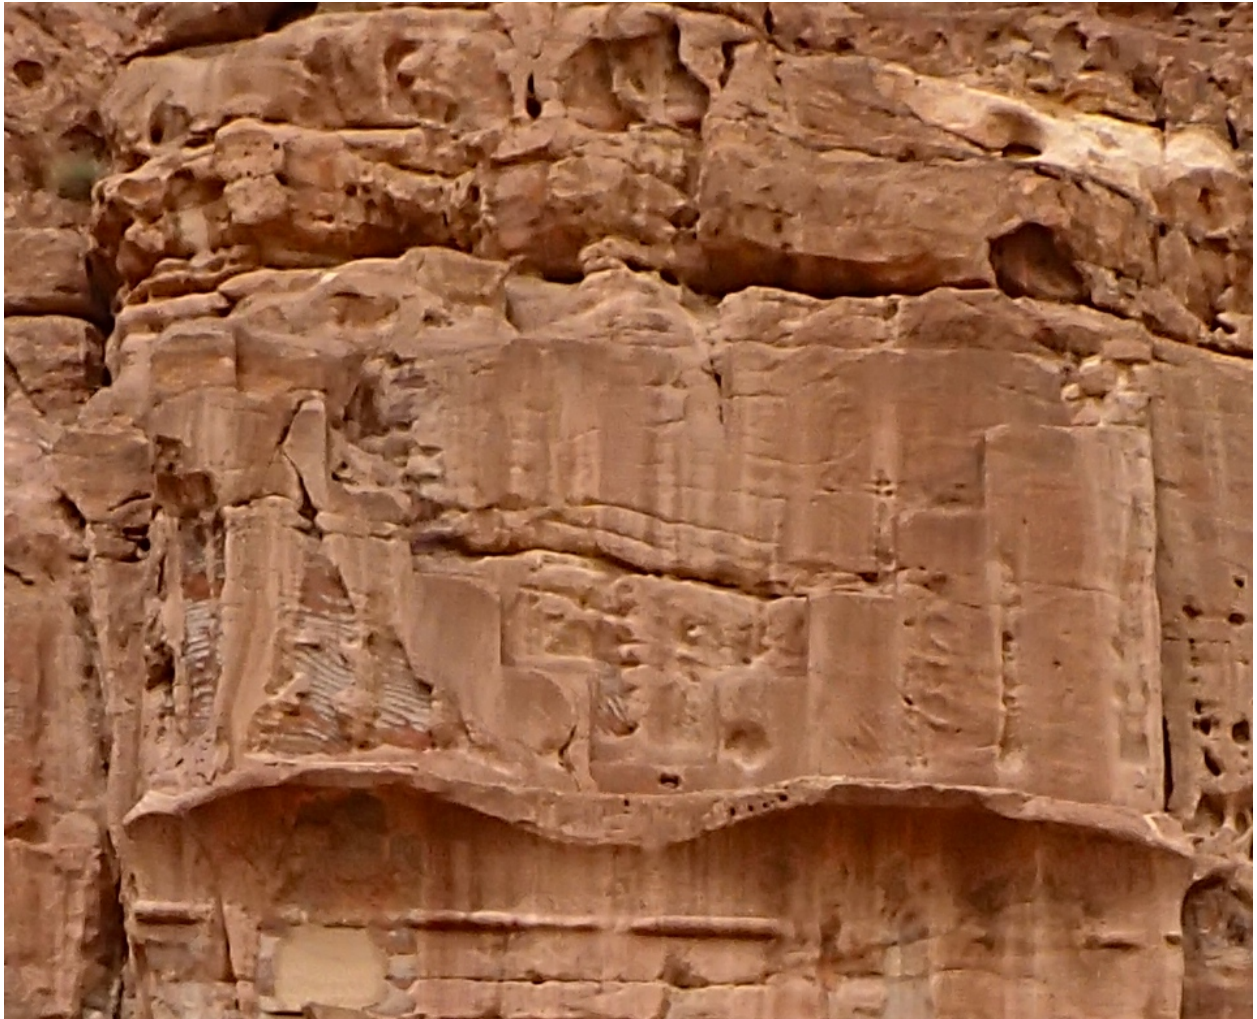
I.10 – Turkmanyia Panel 2—the highest carved panel on the tomb including a row of heavily degraded crow steps. See corresponding CSSI sheet for panel boundaries. Having lost much of its defining details, many of the CSSI assessments compared the current status of the monument with assumed baselines based on conceptual sketches from previous archaeological expeditions. Photograph by author, 2016.

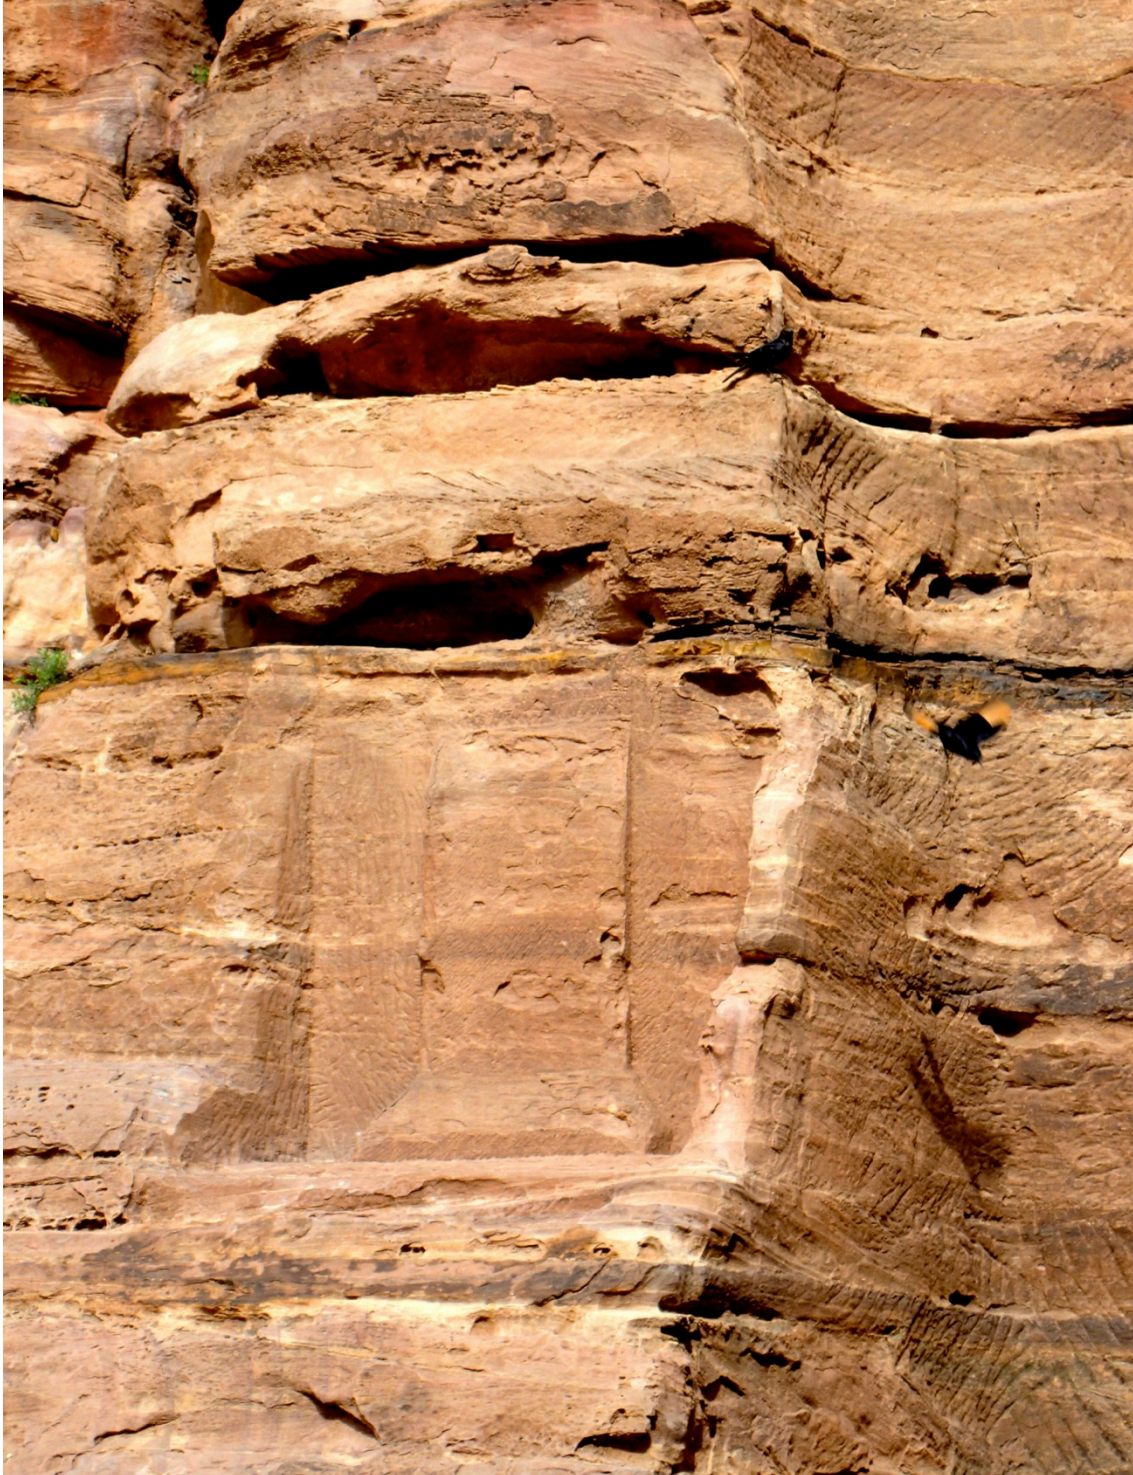
I.13 – Lion Triclinium Panel 1—The small religious niche and surrounding cliff face directly left of the monument when facing the entrance. See the corresponding CSSI sheet for detailed panel definition and included features. Although this niche is technically not part of the Lion Triclinium, its close proximity and presence in Kennedy's historic photograph warranted its inclusion in the assessment. Photograph by author, 2016.

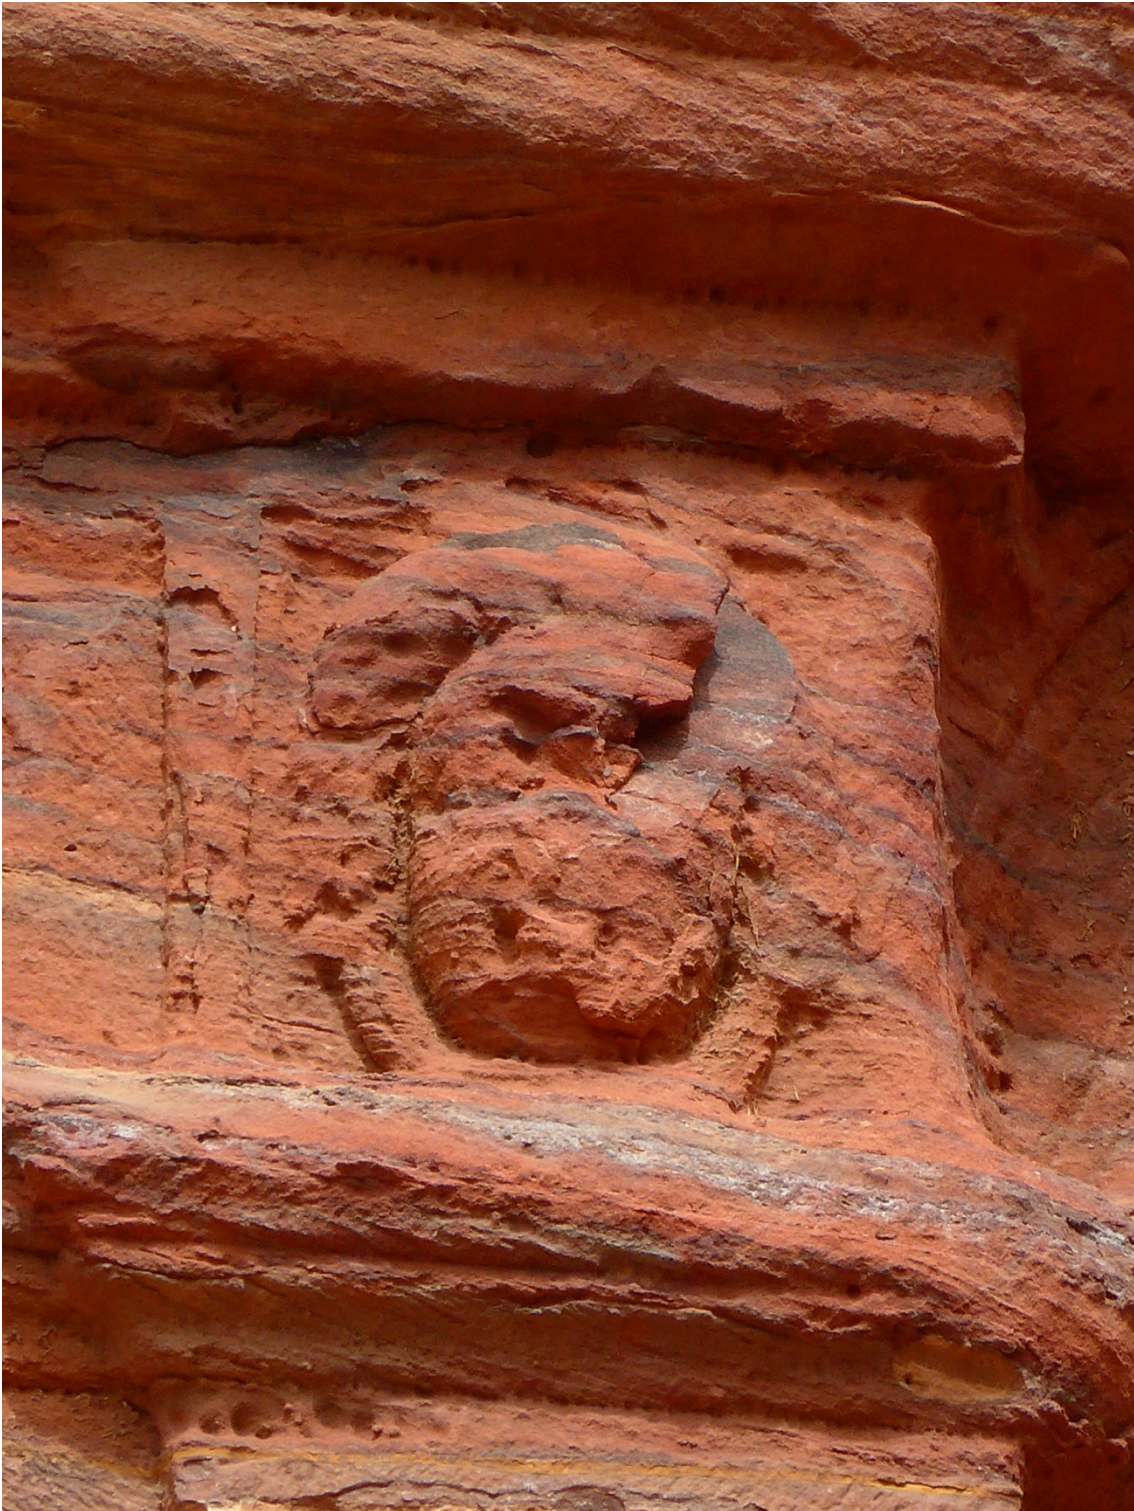
I.16 – Lion Triclinium Panel 10—a close up assessment of the carved face on the top right capital of the monument with adjacent mantels. Too high to photograph from the base of the monument, the image had to be captured from a nearby cliff using a high-definition zoom. Photograph provided by Casey Allen, 2016.
